## **Rule 26 Report**

This report is for the residents at 16207 E. 47th Place, Tulsa, OK 74134. I have prepared a replacement cost estimate for the roof and exterior of this home. I was also asked to review the existing documentation and other written reports that addressed this home and provide my opinions on them.

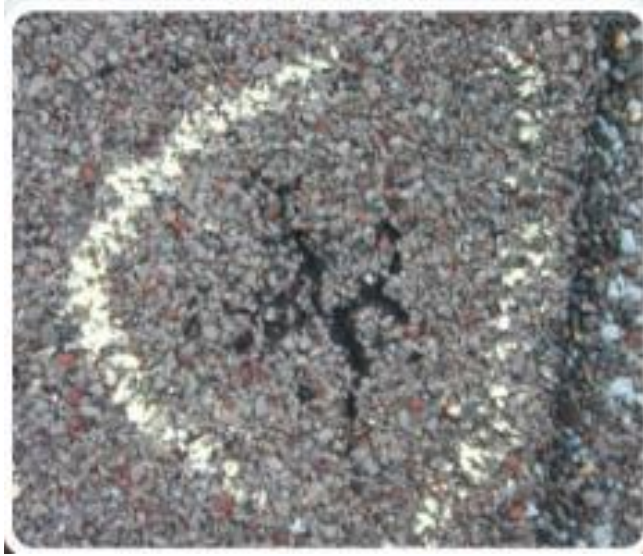
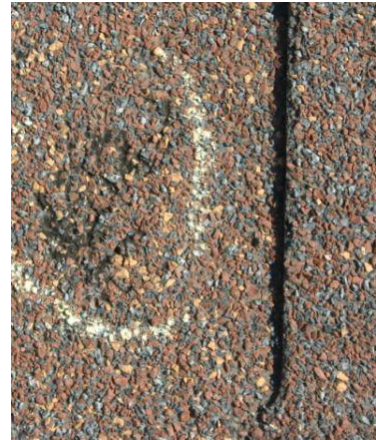
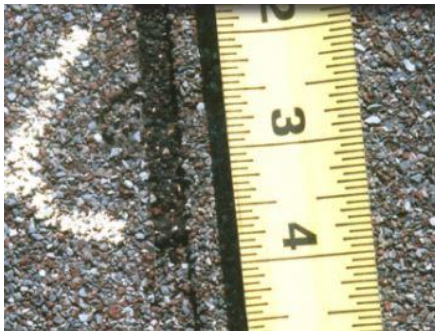
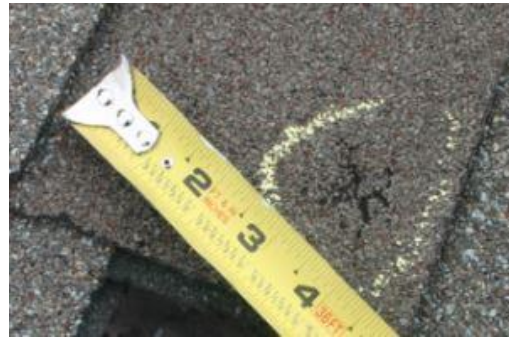
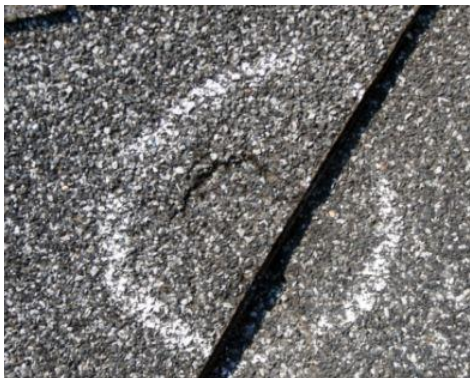
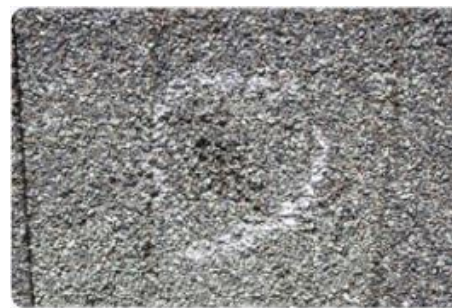
Hail damage on a laminated composition shingle roof surface is identified by bruising, chipping, punctures, or fractures of the laminated composition shingle. This is usually seen by round bruises on a laminated composition shingle. Below are photographs of laminated composition shingles identified by HAAG as damaged by hail:

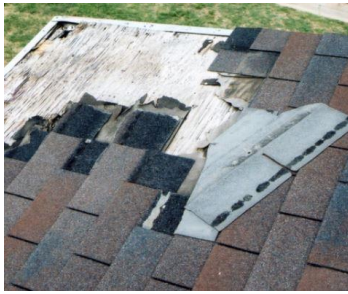
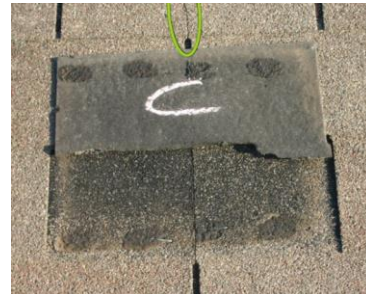
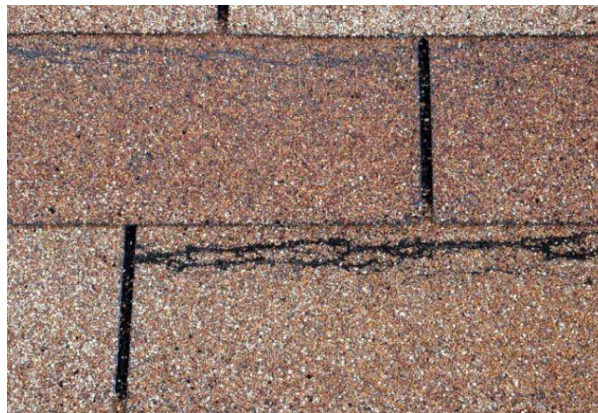
Wind damage on a laminated composition shingle roof surface is identified by missing shingles, lifted shingles, creased shingles, or torn laminated composition shingles. During a windstorm, wind speeds will vary from different directions and can cause more severe damage to different slopes of the roof. Below are photographs of laminated composition shingles identified by HAAG as damaged by wind:

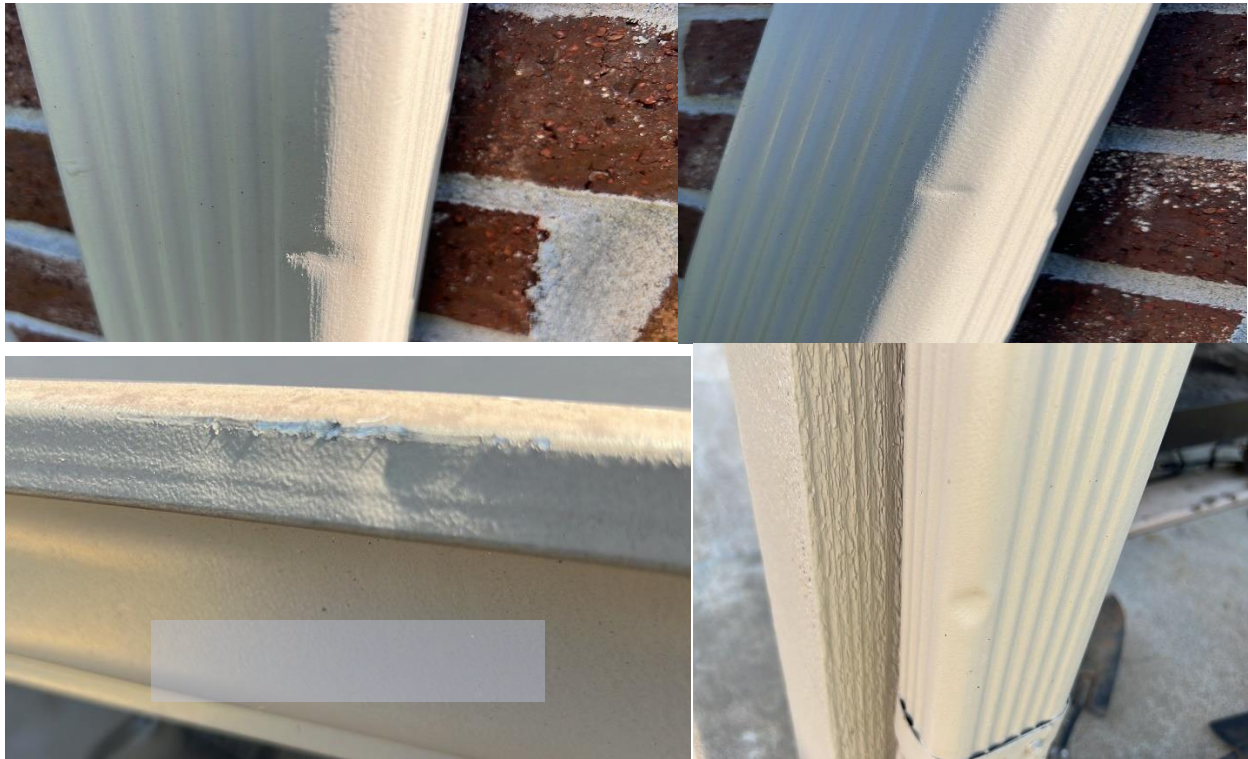
I performed an exterior inspection of the Bales Family's home consistent with the procedure outlined above. I walked the exterior of the home and inspected each elevation. During this inspection, I observed storm damage to gutters and downspouts. As discussed above, hail damage to these metal surfaces is identified by chalking, looking for dents, and feeling the associated dents. Some representative photographs of the associated exterior damage on the Bales Family's home include:

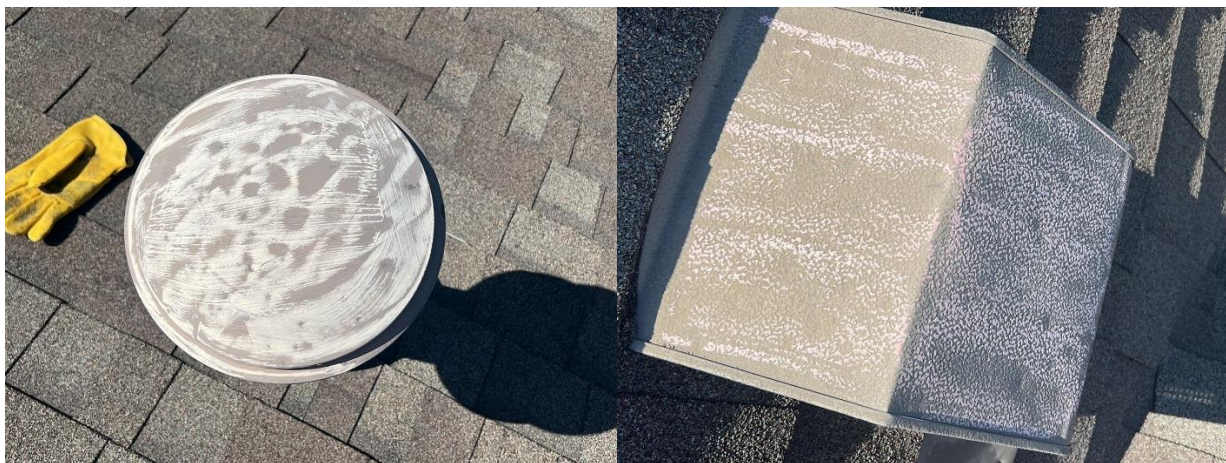
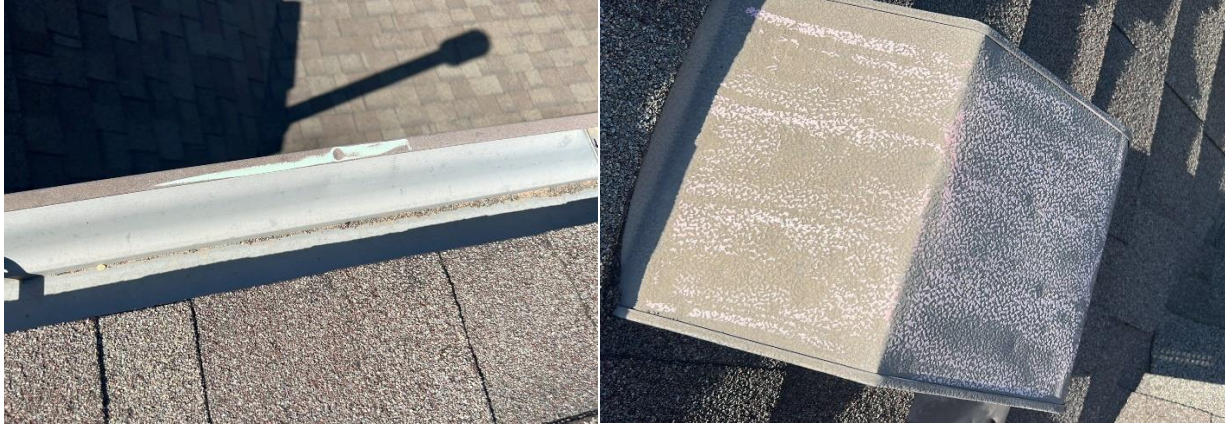
I also accessed the Bales Family's roof via a ladder, Goat, and pitch hoppers to inspect the roof surface. This included chalking of the soft metals for evidence of hail damage in the manner outlined above. This process found several dents that were indicative of hail damage to the Bales Family's soft metals. Some representative photographs of hail damage found to the valleys and soft metals include:

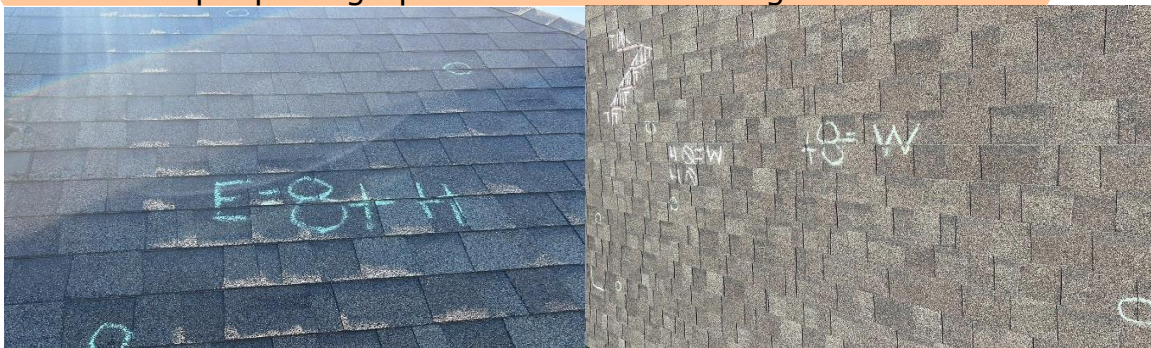
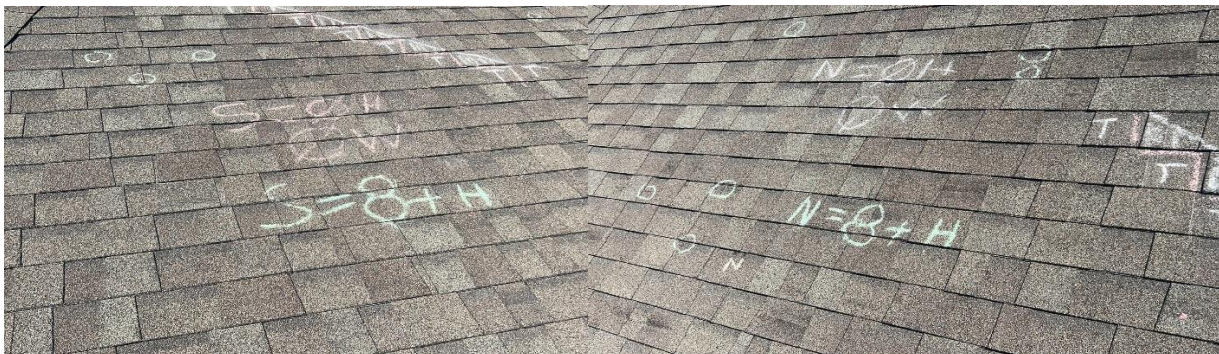
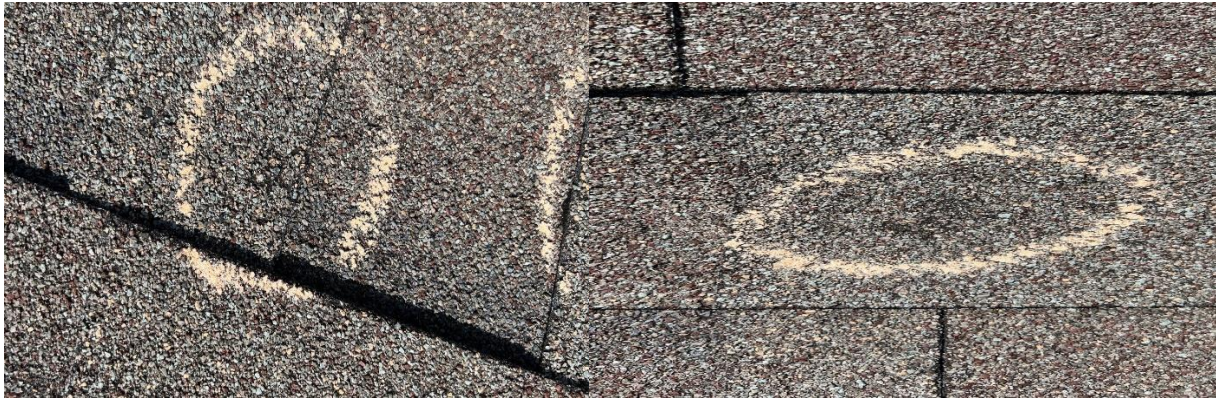
During my inspection of the Bales Family's home, I observed extensive storm damage to the laminated composition shingles and roof surfaces consistent with the descriptions of wind and hail damage described above. Specifically, I performed test squares on each of the slopes to mark and test for hail and wind damage. Within these test squares, I observed bruising, punctures and fractures in the laminated composition shingles indicative of hail damage. I also felt the bruising and dents to the laminated composition shingles to confirm. I also observed lifted shingles indicative of wind damage. There is a tarp covering wind damaged shingles on the lower west hip. I observed additional wind damaged shingles on the upper west slope of the roof. Within each of the test squares I performed, I found 8+ hail hits and/or wind damage. Per roofing and insurance standards, this requires the slopes to be replaced. Some example photographs of the storm damage found include:

Based on my observations described above, it is my opinion the roof surface damage outlined above is associated with wind and hail from the storm in question. The entire roof will need to be replaced.
